WAVERLEY COUNCIL

Coastal Risks and Hazards Vulnerability Study

301015-02526-CS-REP-0001

December 2011

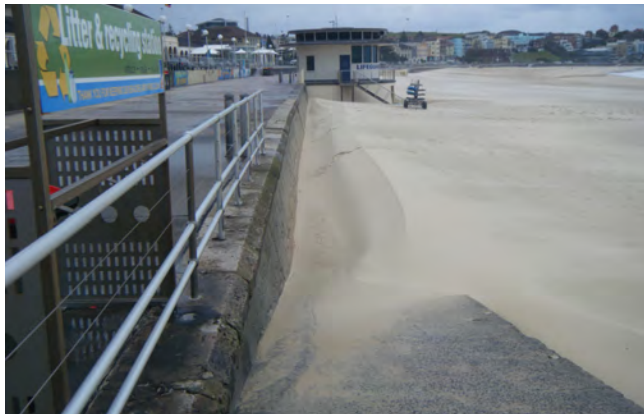
Figure 3.10 Scour in front of Bondi Seawall caused by stormwater runoff

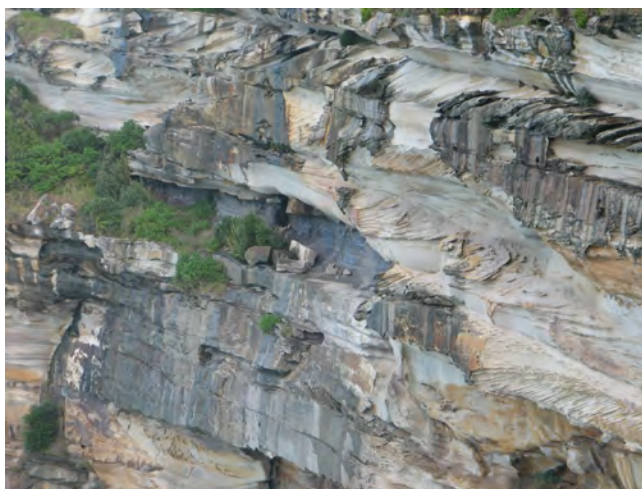
Alternatively, such a failure mechanism would result in the material collapsing and being captured on a flat bench within the cliff face (**Figure 5.2**).

Figure 5.2 Cliff face failure onto cliff bench

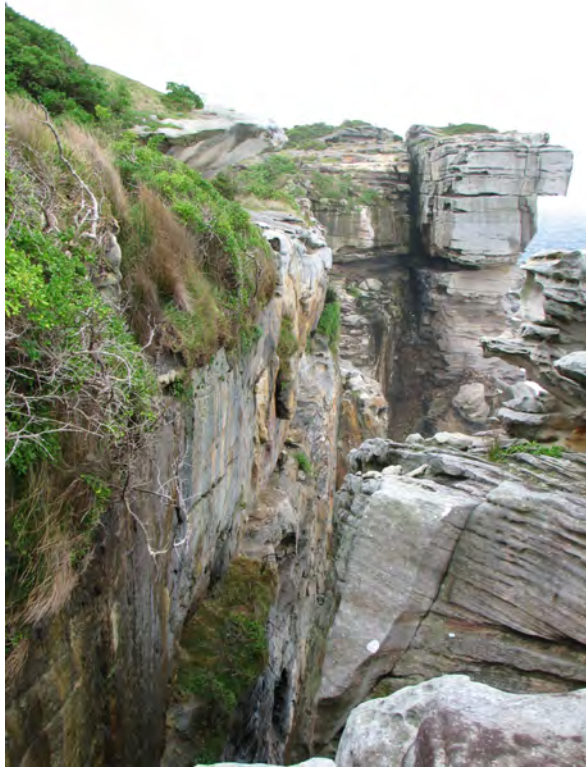
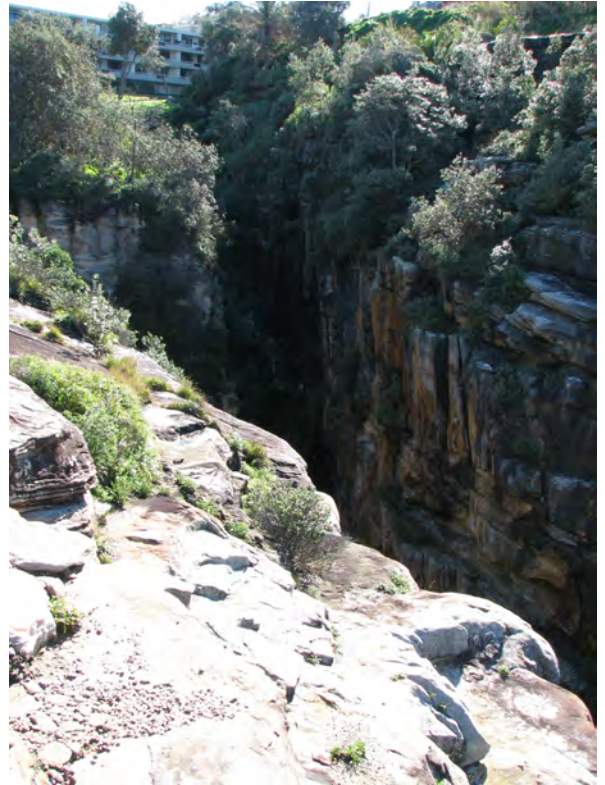
Figure 5.6 Cliff line gullies

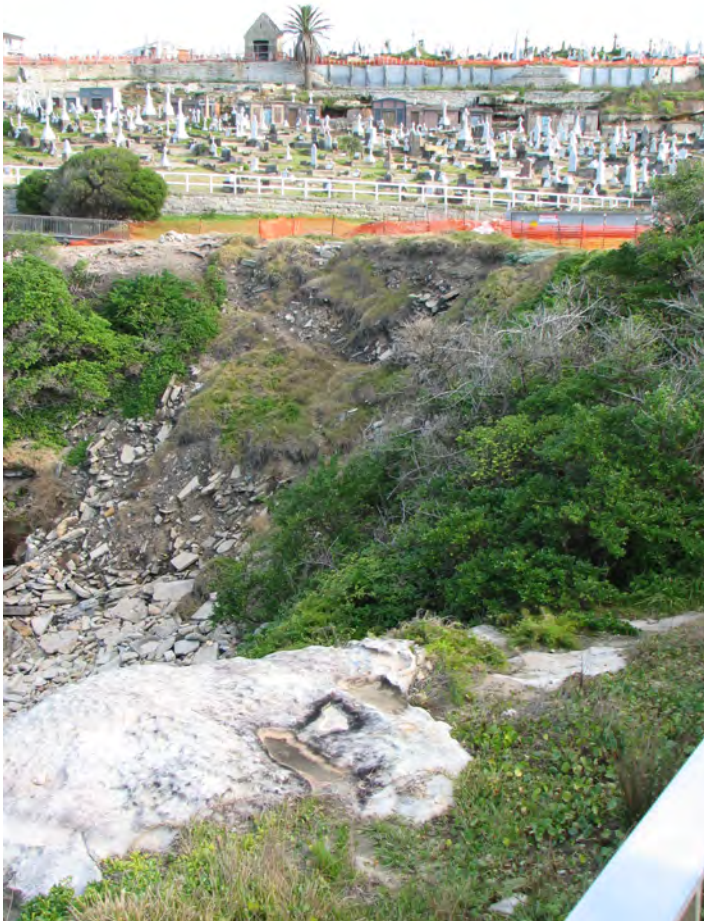
Figure 5.7 Fill batter slope at Waverley Cemetery

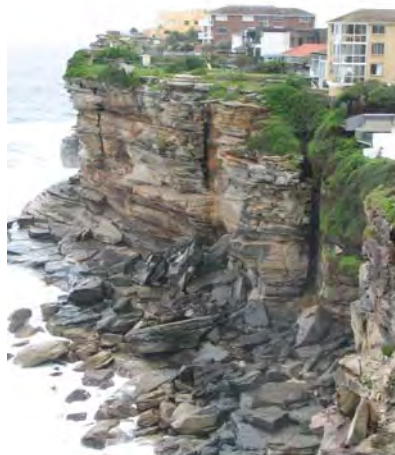
Alternatively, such a failure mechanism would result in the material collapsing and being captured on a flat bench within the cliff face

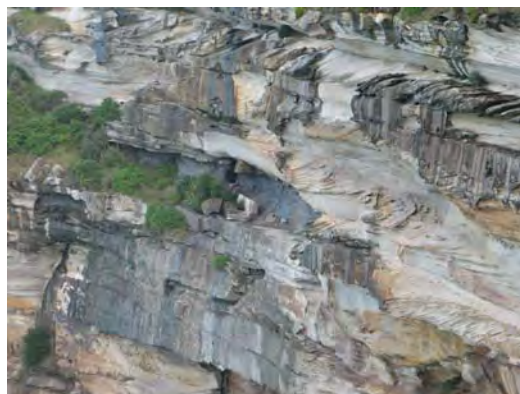
In addition, similar differential weathering and erosion (by wave and wind action) of relatively weak sub-horizontal XWS, shale bands and clay bands over the cliff faces has led to the formation of the numerous cliff top overhang features identified along the study area and undercut features at the base and over the cliff face.

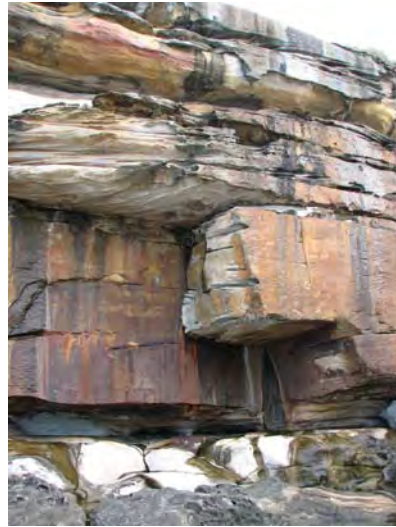
The presence of detached blocks along the wave cut platform is considered to be the product of "recent" (in geological terms) and previous collapses from the cliff faces. The items associated with potential geotechnical hazards 1A, 1B and 1C (as described in Section 4, above) would be associated with continuation of these natural processes. In addition, we note the presence of sub-vertical features, in particular the igneous dykes and/or shear zones identified over the study area which manifest themselves as sub-vertical sided gullies with similar orientations to the orthogonal joint sets described above.
