**Bronte House  
470 Bronte Road, Bronte,  
Sydney, NSW**

**Conservation Management Plan**

Prepared for:  
**Waverley Municipal Council**

Prepared by:  
**Clive Lucas, Stapleton and Partners Pty. Ltd.**  
155 Brougham Street  
Kings Cross, Sydney, 2011  
Telephone: (02) 9357 4811  
Facsimile: (02) 9357 4603

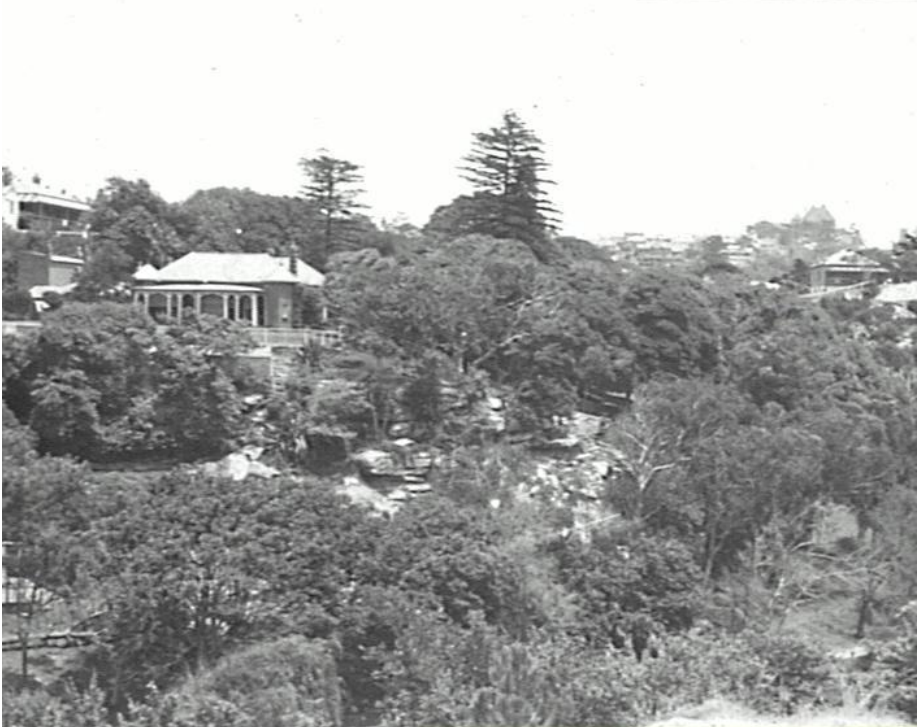
<p><b>Figure 2. 23:</b> Southwest view of Bronte House with two storey wing (Source: Royal Australian Historical Society, 001960)</p>

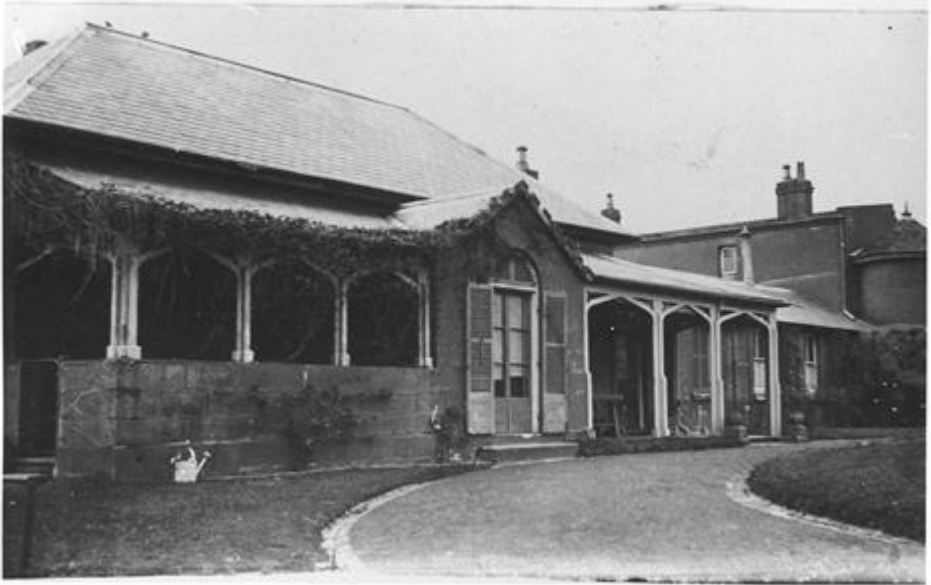
<p><b>Figure 2. 27:</b> Front entry (west elevation) showing northwest glass house replaced with open verandah (Source: CLSP archive files: <i>Bronte House</i>)</p>

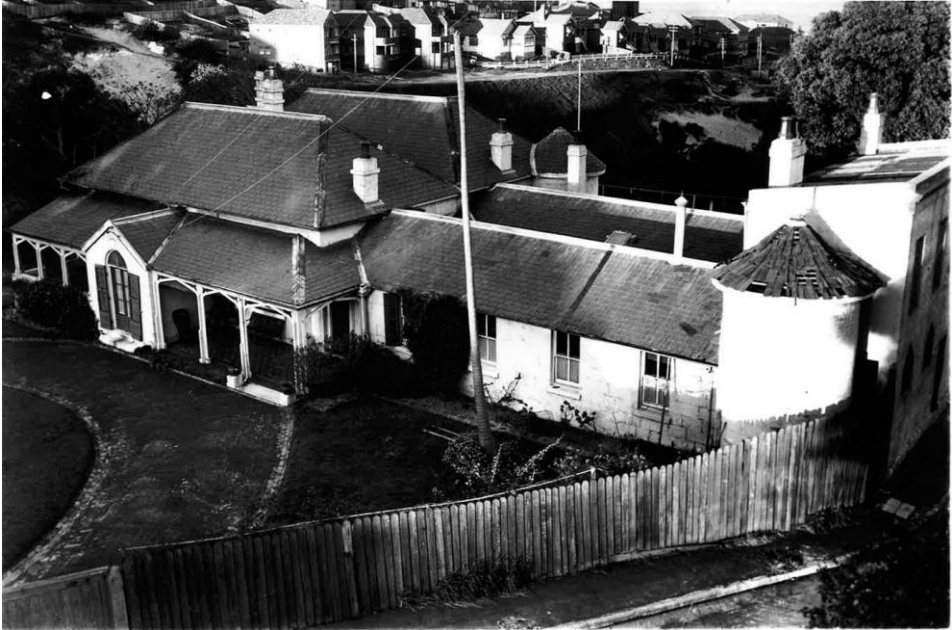
<p><b>Figure 2. 30:</b> Bronte House showing west elevation and roof forms, prior to hand over to Waverley Council (Source: F J Halmark photograph, Sydney Morning Herald, CLSP archive files: <i>Bronte House</i>)</p>
1948

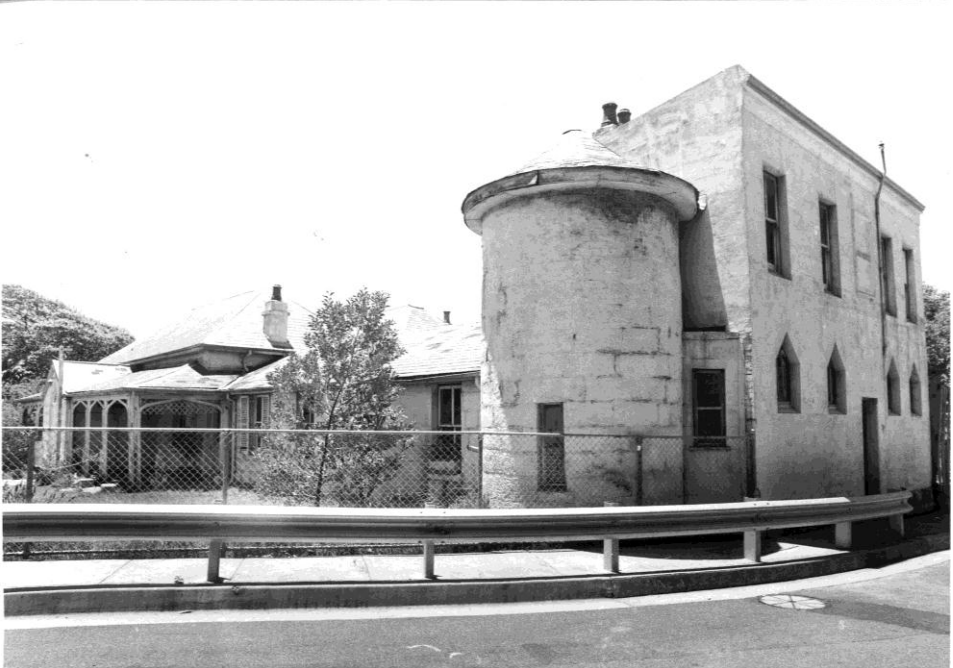
<p><b>Figure 2. 34:</b> West and South elevations of Bronte House pre-restoration (Source: CLSP archive files: <i>Bronte House</i>)</p>
Post 1983

Date	Event
Late 1970s	Bronte House is leased for wedding receptions and parties and many unsympathetic alterations made.
1980s	House in dilapidated state with elements falling off (see Figure 2. 34)
1981	Major repair and reconstruction of exterior by Ian Stapleton of Fisher Lucas Pty Ltd architects, including reconstruction of external elements from old photographs, including rebuilding of East wall to service wing (refer to <i>Physical Survey</i> below for further details).
1982	Double garage with store constructed near entrance gates on Lot 8.
1983	Waverley Council enters into 25 year 'repairing lease' with Mr Christopher Selmes.
1983	Major internal repairs, reconstruction and fitouts by Clive Lucas of Clive Lucas Pty Ltd architects, including: <ul style="list-style-type: none"> <li>• Reconstruct Bed 1 (R4A/R4B) walls</li> <li>• Demolish R9/R10 wall</li> <li>• Stair partition in R11</li> <li>• Block of W13 and W14</li> <li>• Construction of R14B</li> </ul>

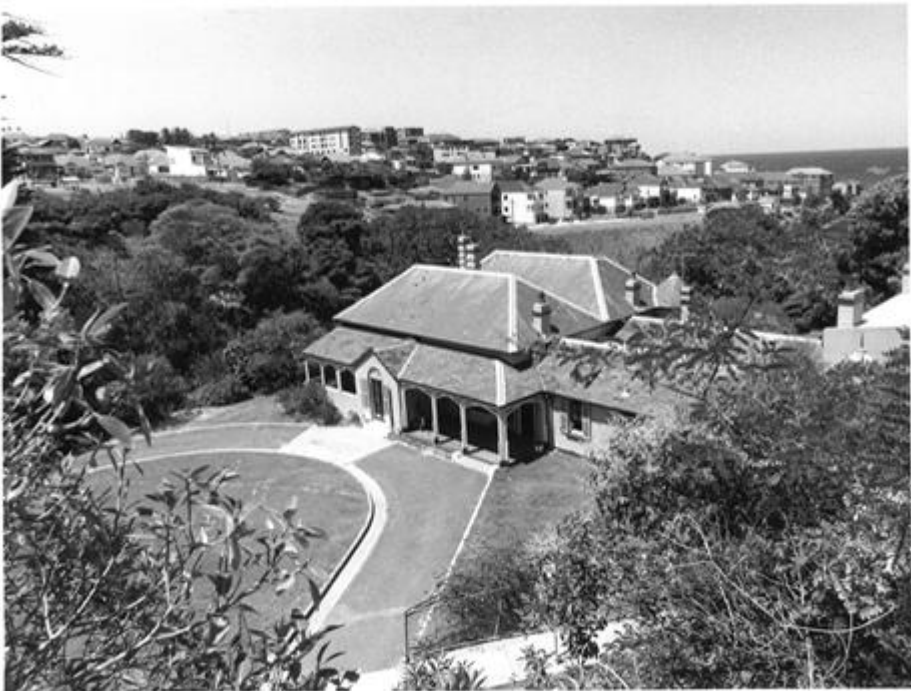
<p><b>Figure 2. 35:</b> West elevation and roof of Bronte House post-restoration (Source: CLSP archive files: <i>Bronte House</i>)</p>

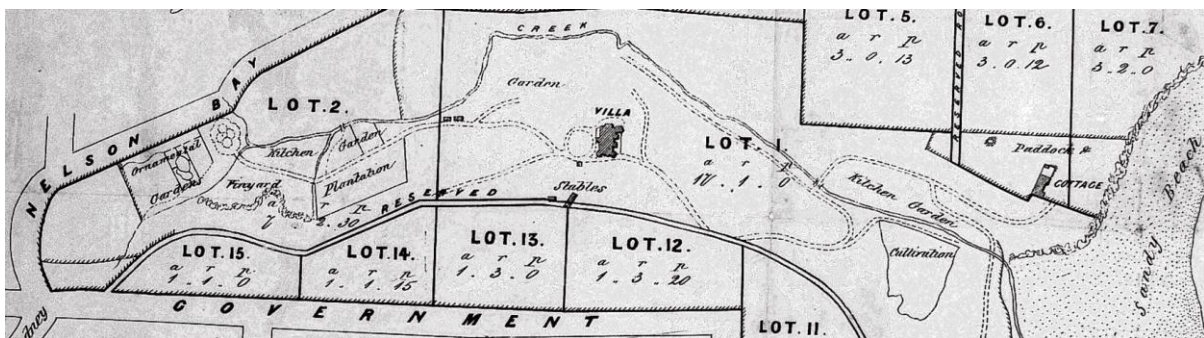
<p><b>Figure 2. 41:</b> Extract from Reuss and Browne plan for subdivision of the estate showing layout of garden including various landscape features. (Source: Mitchell Library subdivision plans)</p>

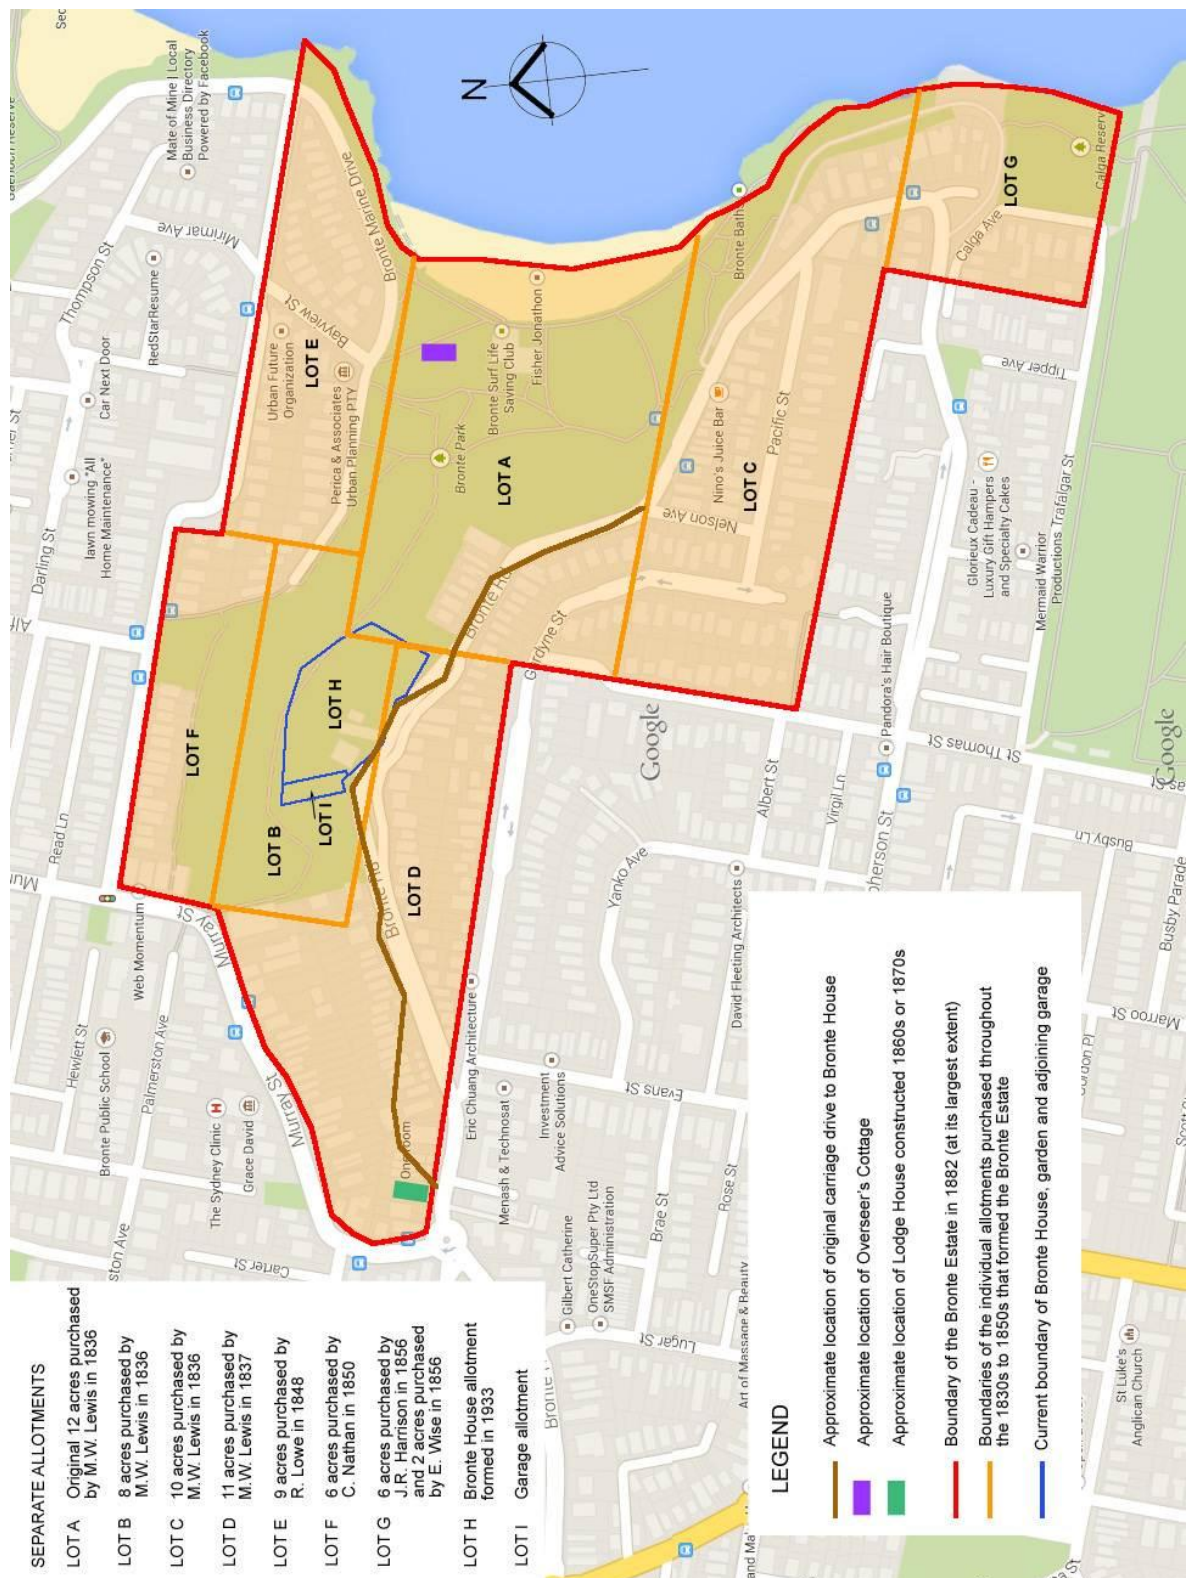
**Figure 2. 135:** Diagram showing the various allotments that have formed the Bronte estate over time and the identification of historic features

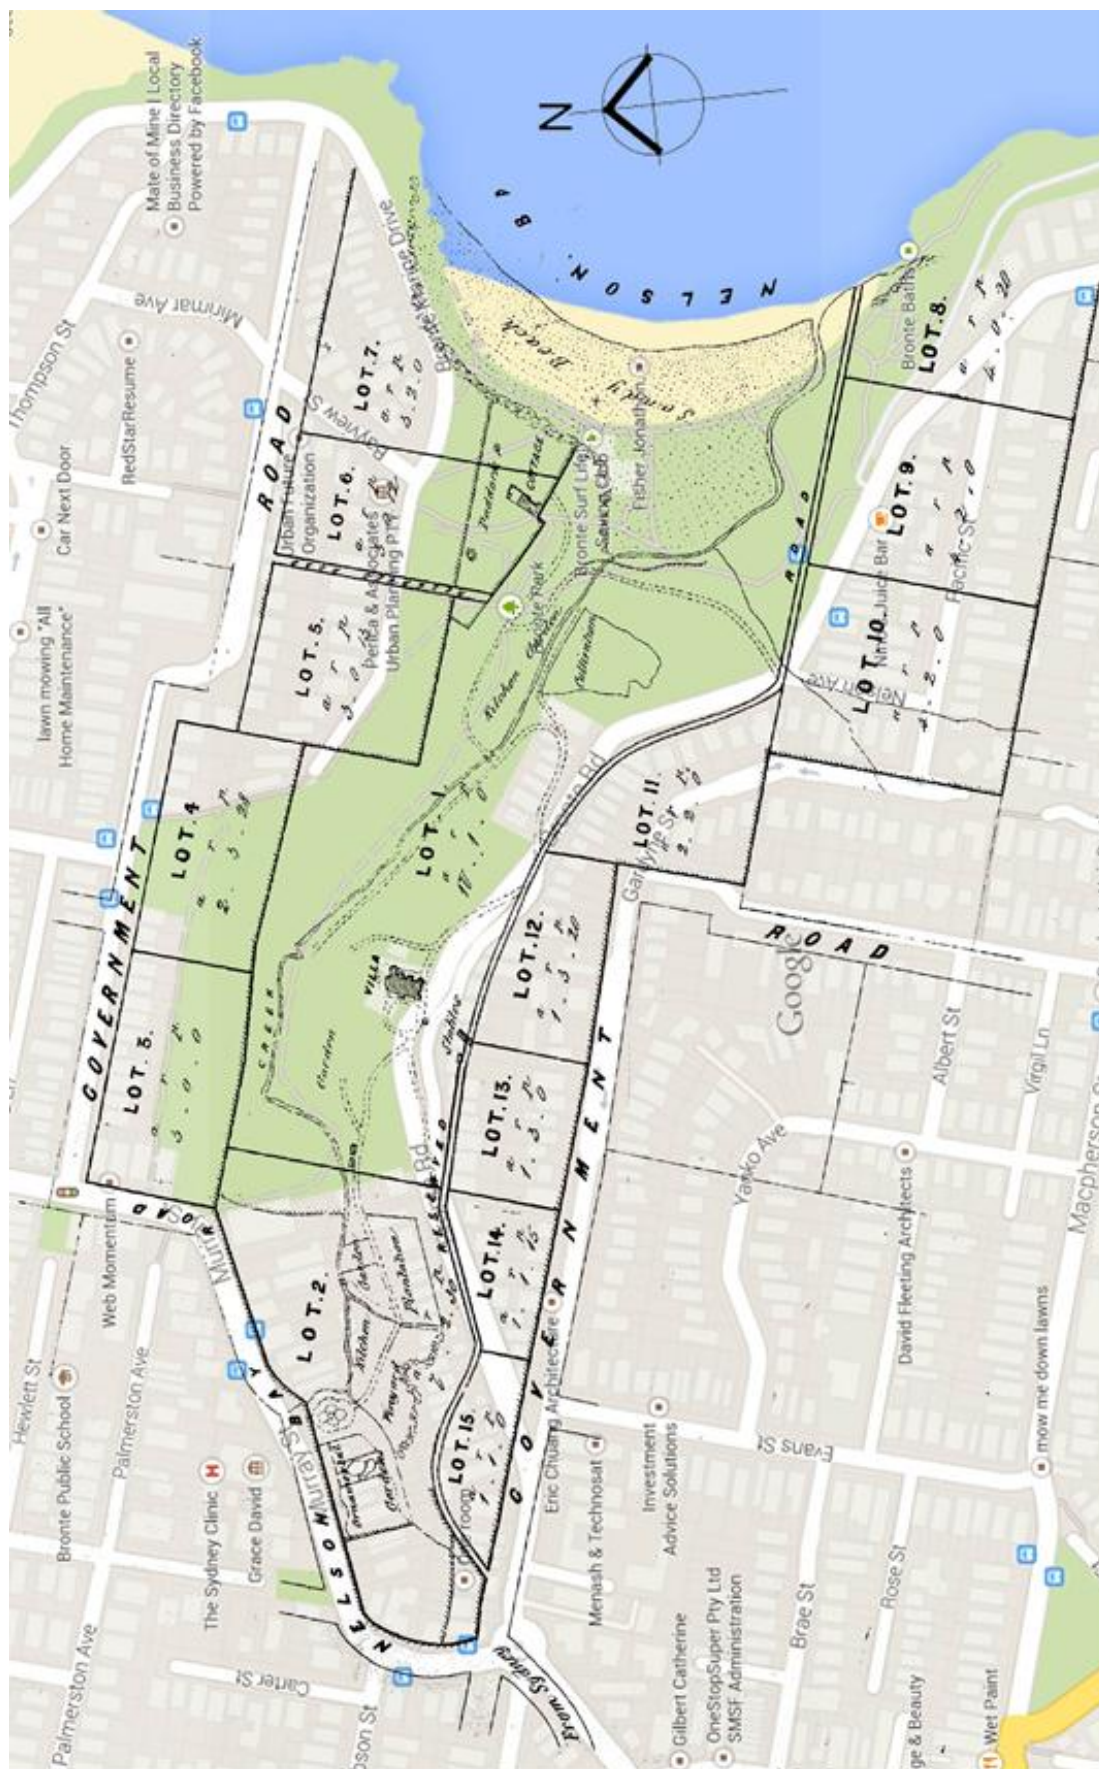
**Figure 2. 136:** Overlay of 1861 Reuss and Browne subdivision plan on current street map showing layout of estate lands and approximate location of former site features from that time.

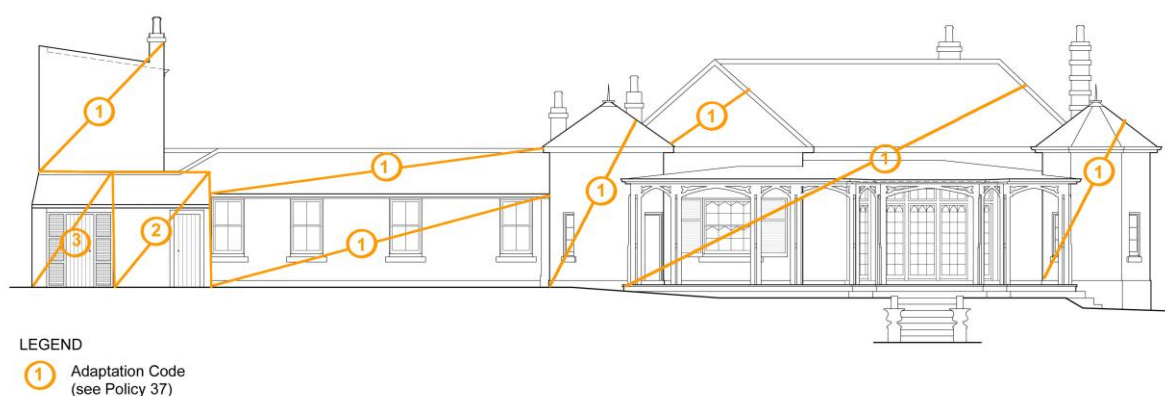
**Figure 6. 4:** East elevation adaptation plan

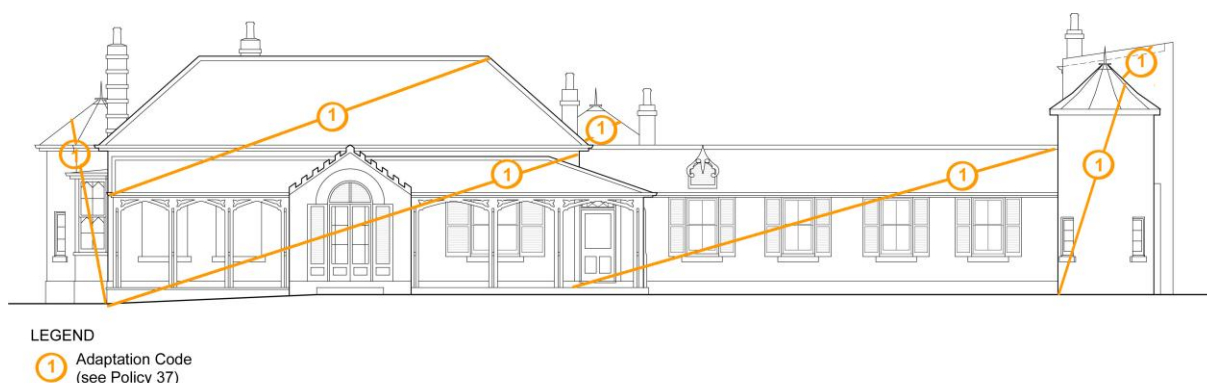
**Figure 6. 5:** West elevation adaptation plan
