WAVERLEY COUNCIL

Coastal Risks and Hazards Vulnerability Study

301015-02526-CS-REP-0001

December 2011

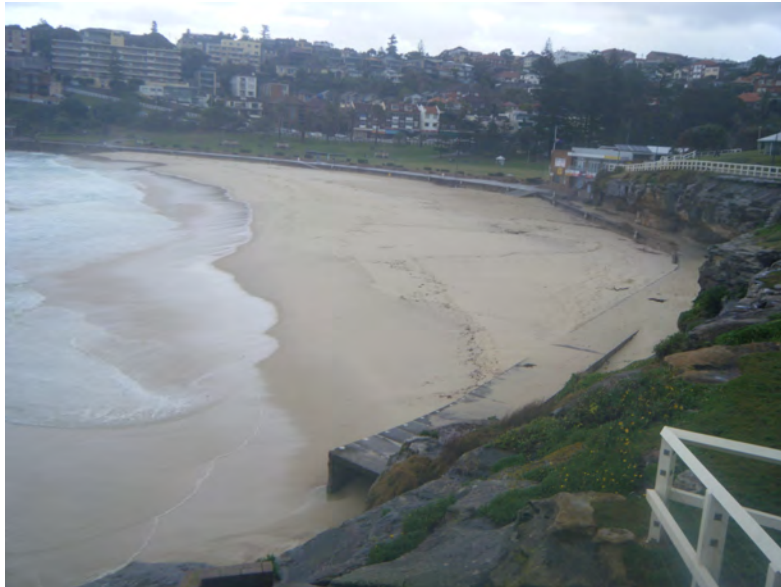
Today Bronte Beach attracts many sunbathers, swimmers and surfers with the large park, picnic area and good access and parking adding to its appeal. Rips occur along the beach. Similar to Bondi Beach, Bronte Beach also have some issues at times with sand blowing onto the promenade (refer **Figure 2.17**).

Figure 2.17 Bronte Beach, June 2011

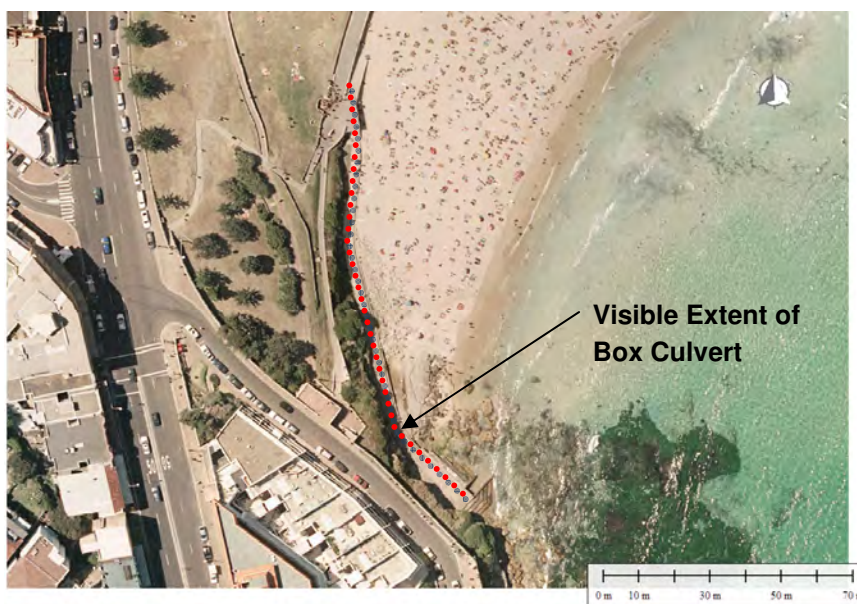
Bondi and Bronte stormwater systems discharge onto rock, seaward of the beach sand and, therefore, are unlikely to cause erosion of beach sand and would not be expected to supply any significant quantities of sand to the beach system. Tamarama stormwater system discharges onto sand. However, it extends most of the distance beyond the beach sand and it would be expected that rock would be at a very shallow level at the outfall location. Therefore it is also unlikely to cause significant erosion of beach sand and would not be expected to supply any significant quantities of sand to the beach system.

Figure 3.6 Southern end of Bondi Beach stormwater

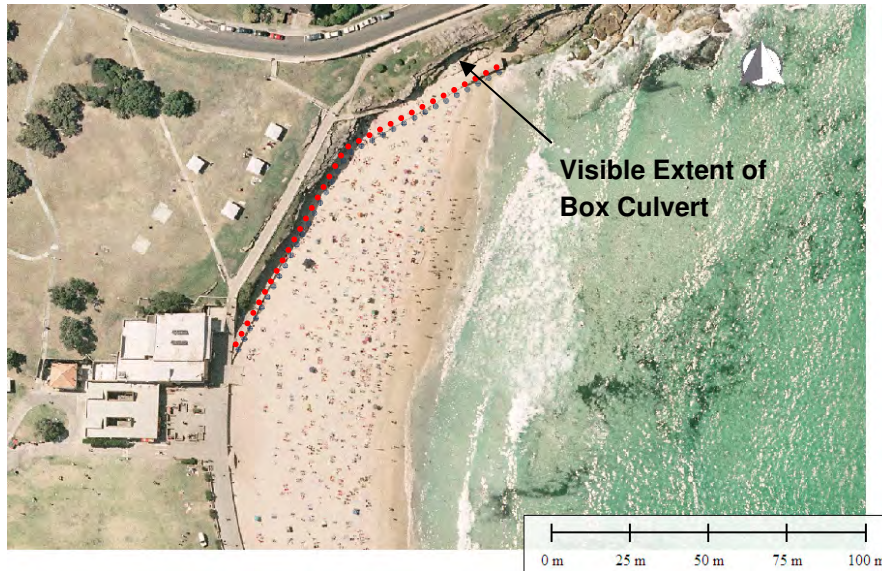
Figure 3.8 Northern end of Bronte Beach stormwater

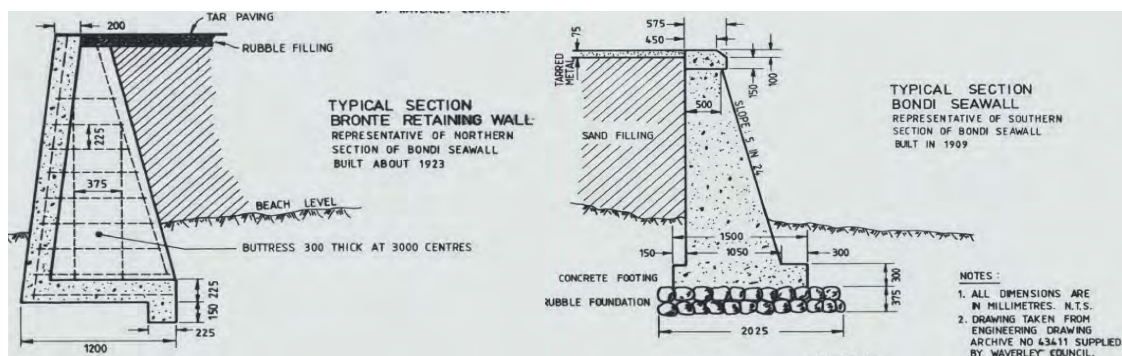
Figure 3.13 Reproduction of Historical Design Drawings of Bondi and Bronte Seawalls (Source: PWD, 1988)

The sea wall and promenade were constructed at Bronte Beach between 1914 and 1917. PWD 1988 indicated that the Bronte seawall design was similar to the northern section of Bondi seawall (refer **Figure 3.13**). This suggests that the Bronte seawall is of reinforced concrete counterfort wall construction. The seawall runs the entire length of the beach between the headlands. No data has been able to be sourced on the toe levels of the base of the seawall.

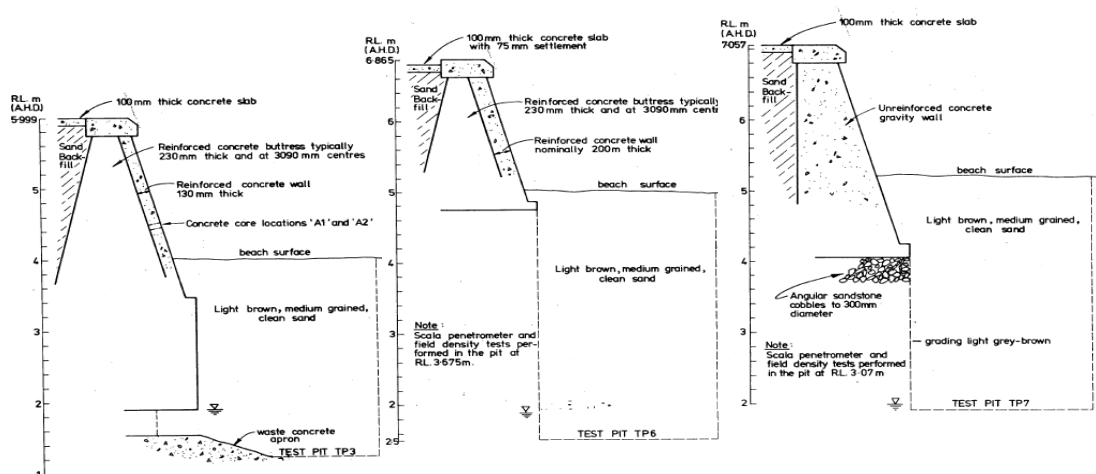
Investigations on the Bondi seawall structure were undertaken by PWD 1988, this included metal detection of reinforcement, 17 concrete core samples (into the face of the seawall), sediment sampling and site excavations (10 boreholes and 15 test pits). These investigations (refer **Figure 3.14**) suggested that the historical design drawings (**Figure 3.13**) provide a reasonable representation of the seawall. A long section of the seawall, showing the varying toe depth along its length, is included as **Figure 3.17**). The seawall details outlined below are taken from the PWD 1988 report.

In 1909 the southern section of the seawall was constructed. This southern section of the seawall (approximately south from the Pavilion) is an unreinforced concrete gravity wall. According to test pits, the toe level of the concrete is around 2 m AHD in some sections and around 4 m AHD in other sections. In some areas bed of sandstone gravel and cobbles up to 300 m thickness was observed beneath the wall. Concrete core tests suggested an average concrete compressive strength of 12 MPa.

The seawall was extended to the northern end of the beach in about 1923. This section of seawall is a reinforced concrete counterfort wall. According to test pits, the toe level of the concrete is around 4 m to 4.7 m AHD for most of its length, with some sections at around 2 m AHD in the north. Investigations suggested that the reinforcement consists of 10 mm diameter bars, with horizontal bar spacing 230 to 300 mm and bar vertical spacing of 400 to 580 mm and cover of 35 to 50 mm. Concrete core tests suggested an average concrete compressive strength of 20 MPa.

Figure 3.14 Cross Sections from test pits (Source: PWD 1988)

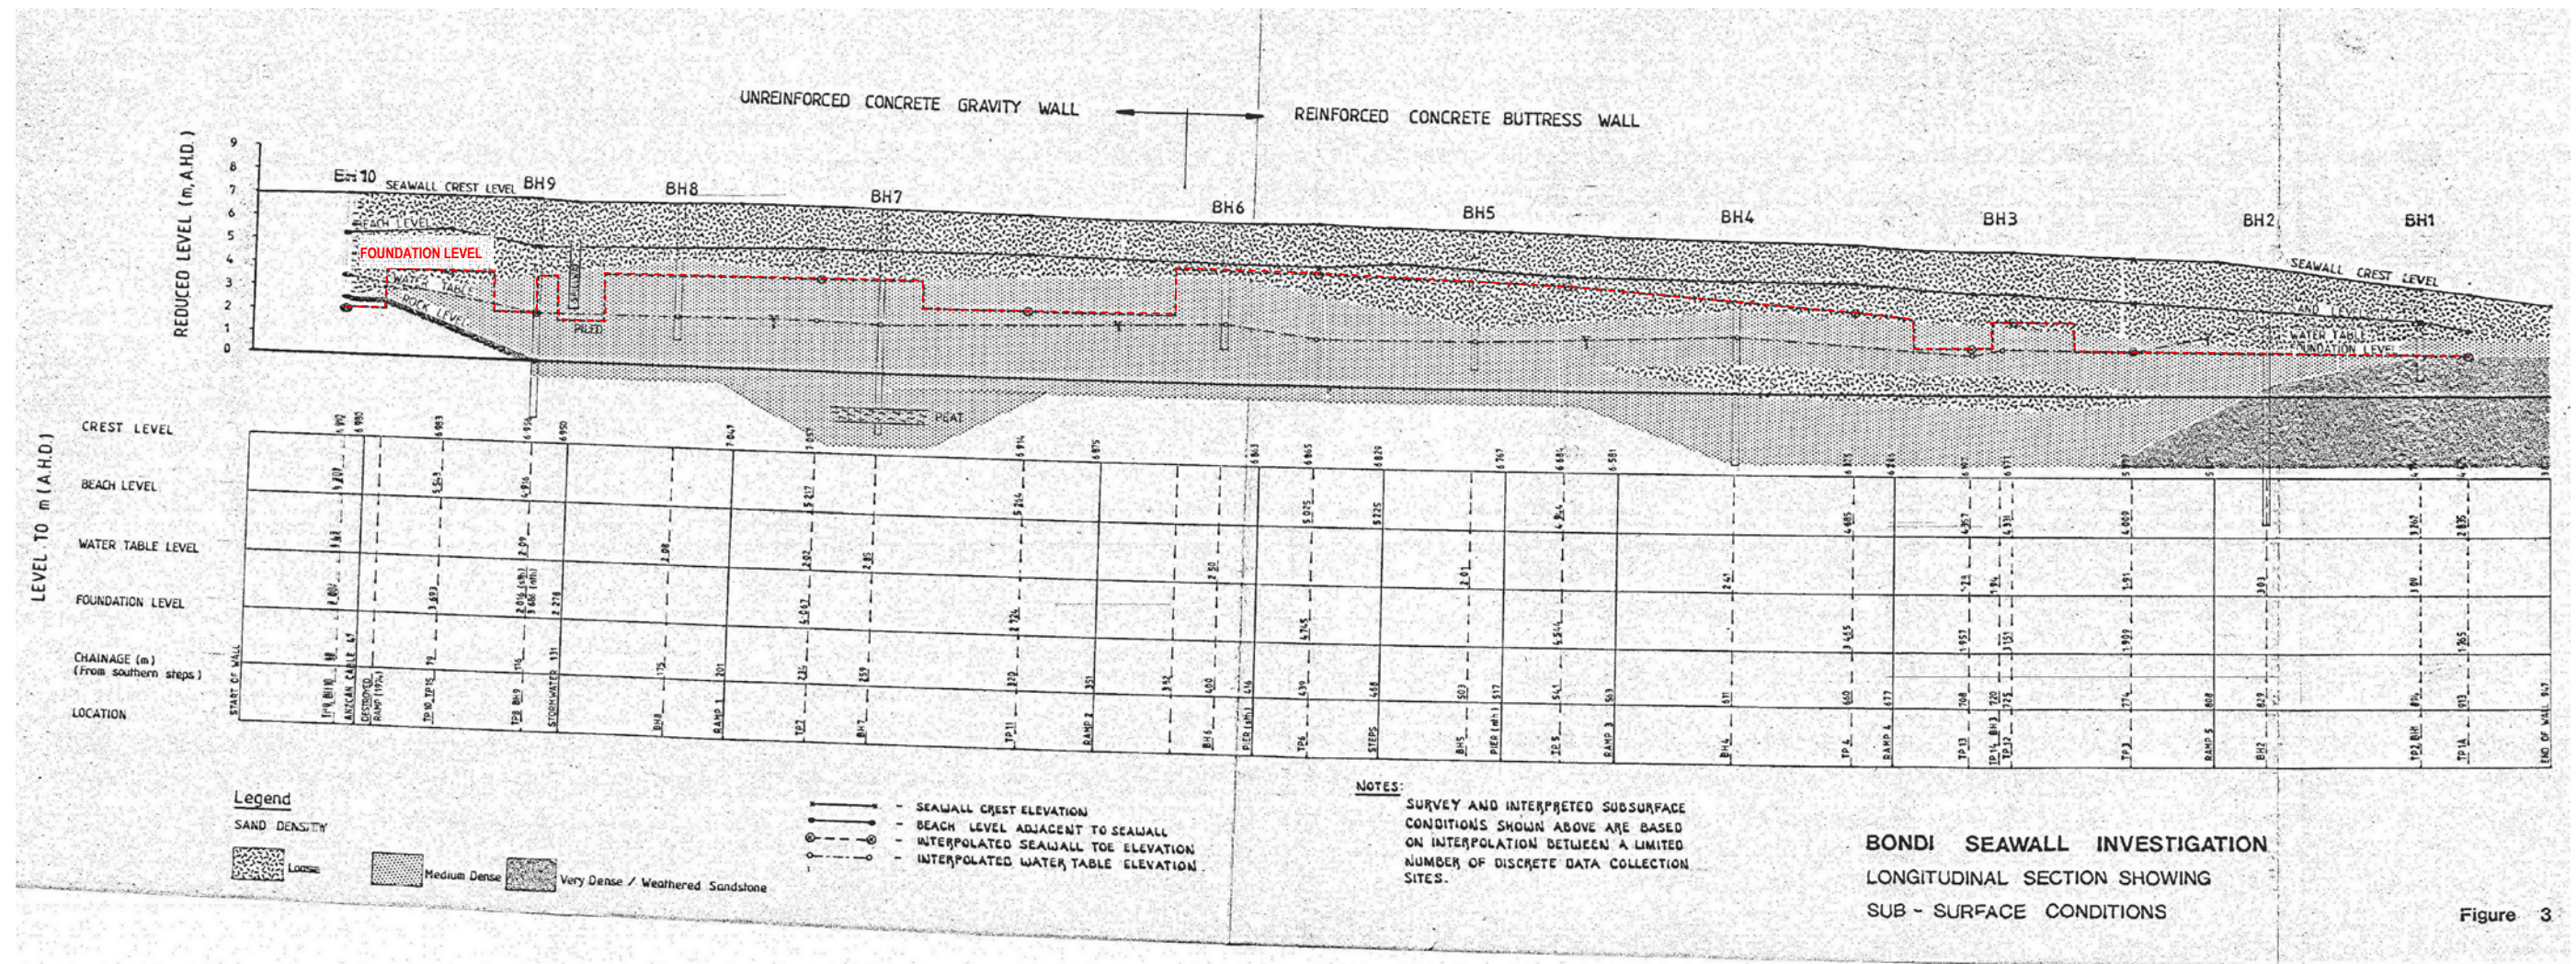
Figure 3.17 Long Section Of Bondi Seawall and Foundations (Source: PWD 1988)

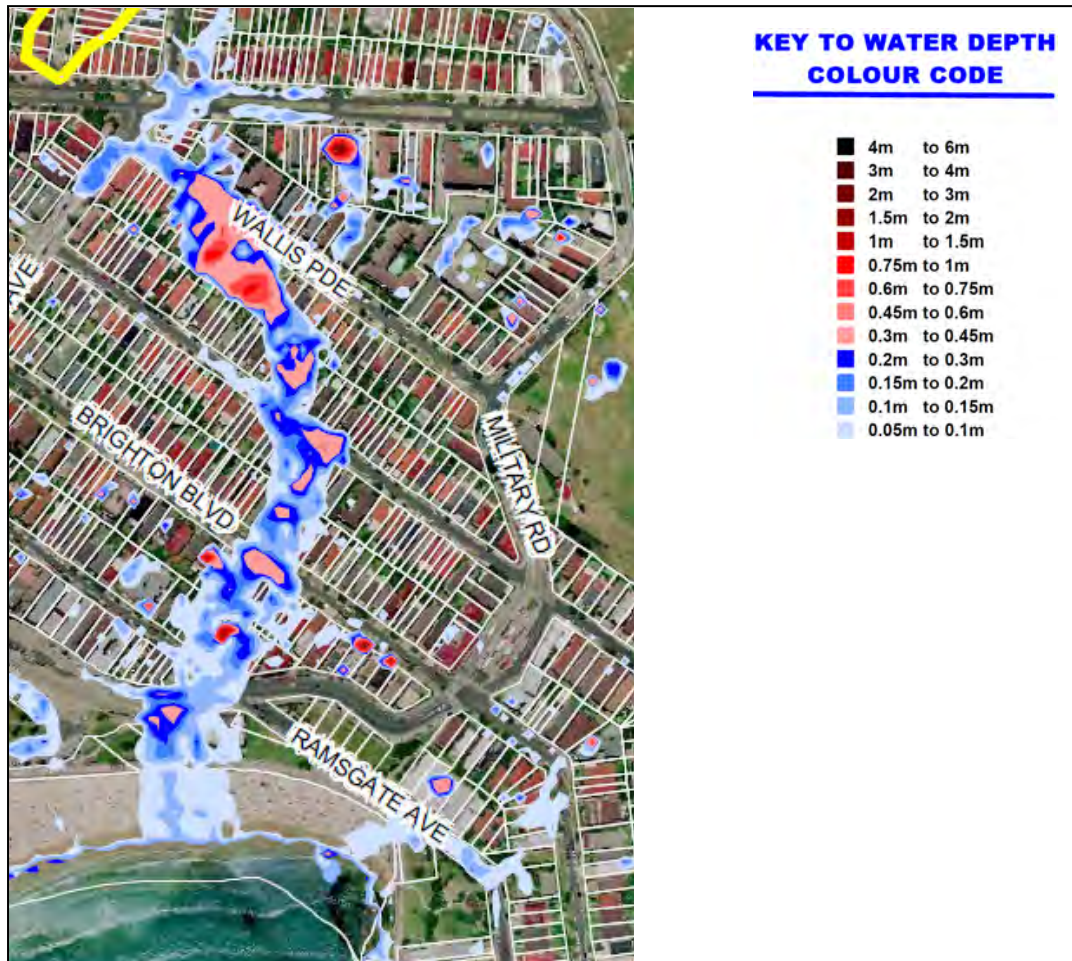
Figure 4.13 Approximate modelling of Overland Flows in 100 year ARI event Source: Civic Design, 2007)

The water level in basin 10 during a 1 year ARI event is around 16.4 m AHD. Under present day conditions, the still water level on the beach during an extreme storm could reach around 2.5 m AHD, which may persist for an hour or two on the top of the tide, flooding the obvert of the box culvert (RL 2.36 m AHD). With climate change sea level rise, this level is projected to increase to 2.9 m AHD for the year 2050 and 3.4 m AHD for the year 2100.

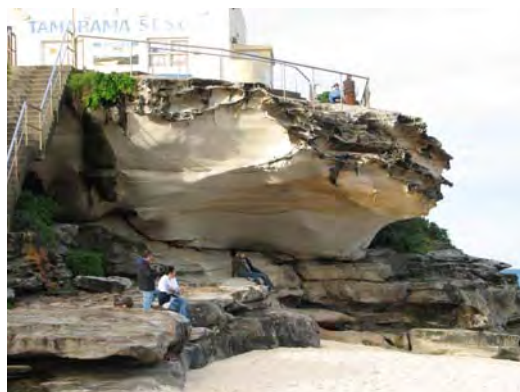
In addition, similar differential weathering and erosion (by wave and wind action) of relatively weak sub-horizontal XWS, shale bands and clay bands over the cliff faces has led to the formation of the numerous cliff top overhang features identified along the study area and undercut features at the base and over the cliff face.

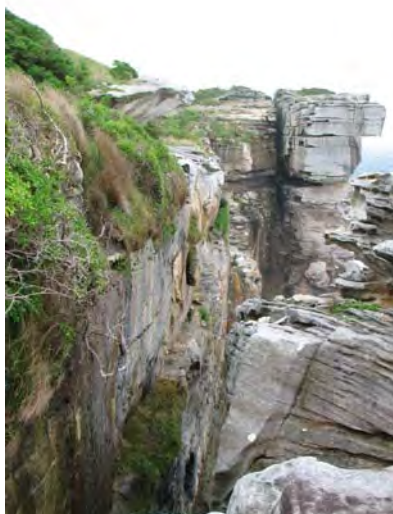
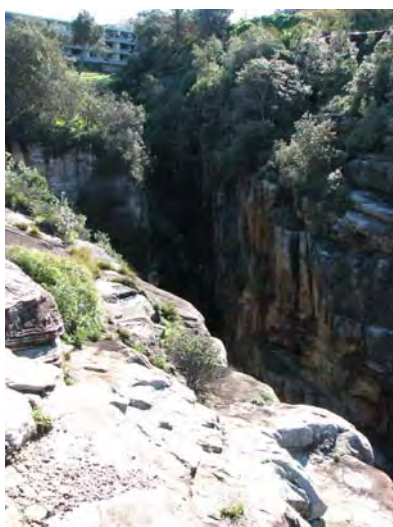
The igneous dykes and shear zones typically comprise extremely weathered/residual soil materials which are often fractured. These relatively weaker sub-vertical features are also affected by differential weathering and erosion (by wave and wind action) and have resulted in the formation of the cliff line gullies described in Section 3, above.

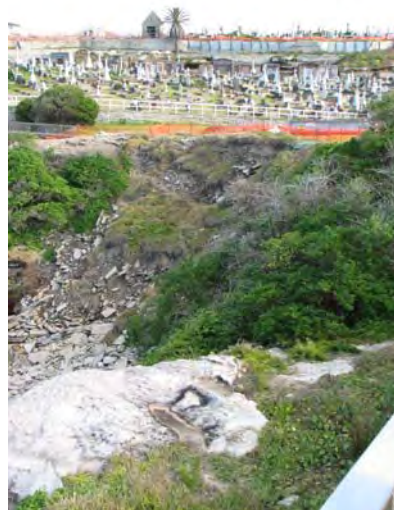
Instability of soil slopes over sections of the cliff faces was also identified at selected locations. Instability of such slopes is typically governed by one or more of the following factors; over-steep batter slopes, elevated water pressures within the soils associated with ineffective drainage systems and/or surface water run-off and erosion of the toe of the slopes by wave action.

The most dramatic example of a number of these factors affecting one slope was the fill batter slope infill of the gully feature within Waverley Cemetery.

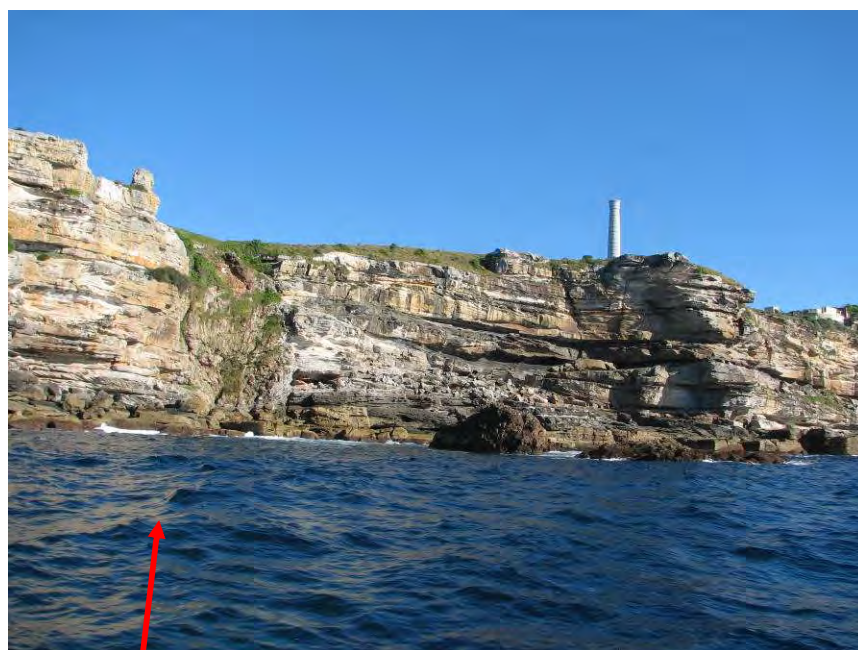
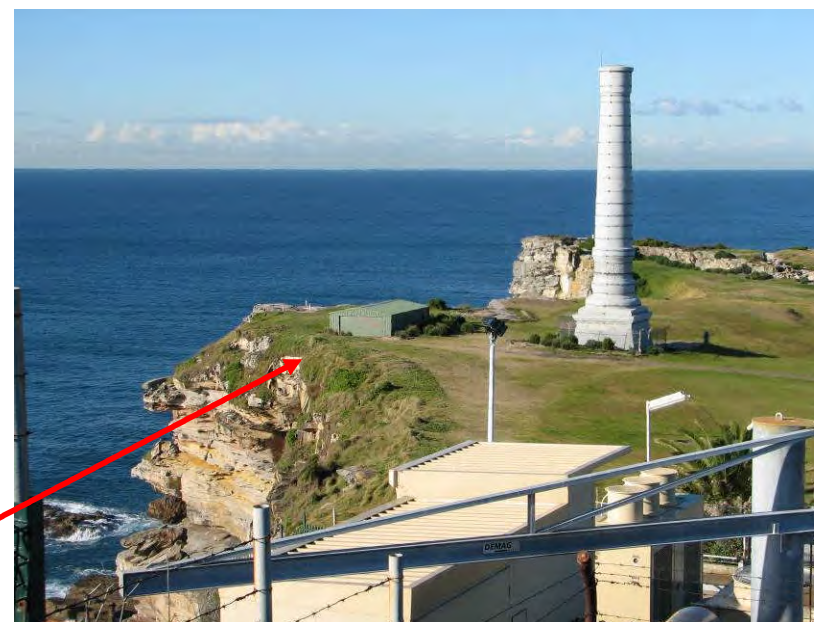
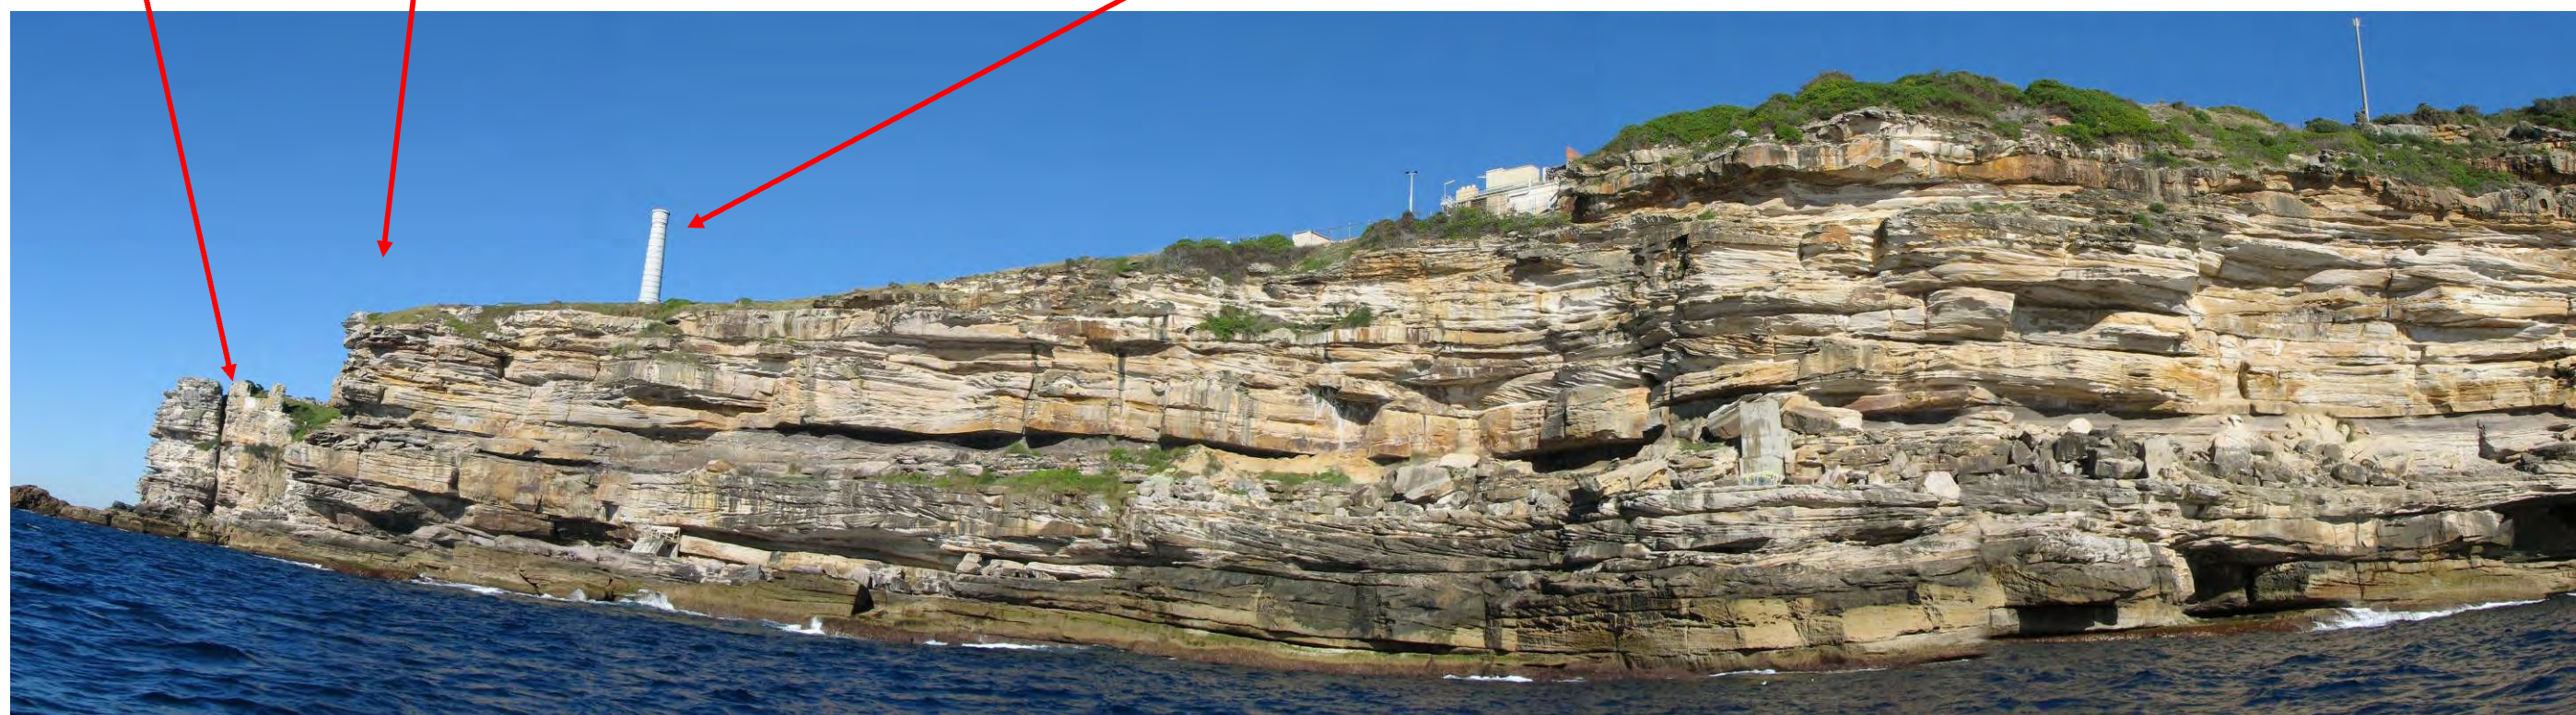
Bondi Sewage Treatment Works

Trace of igneous
dyke

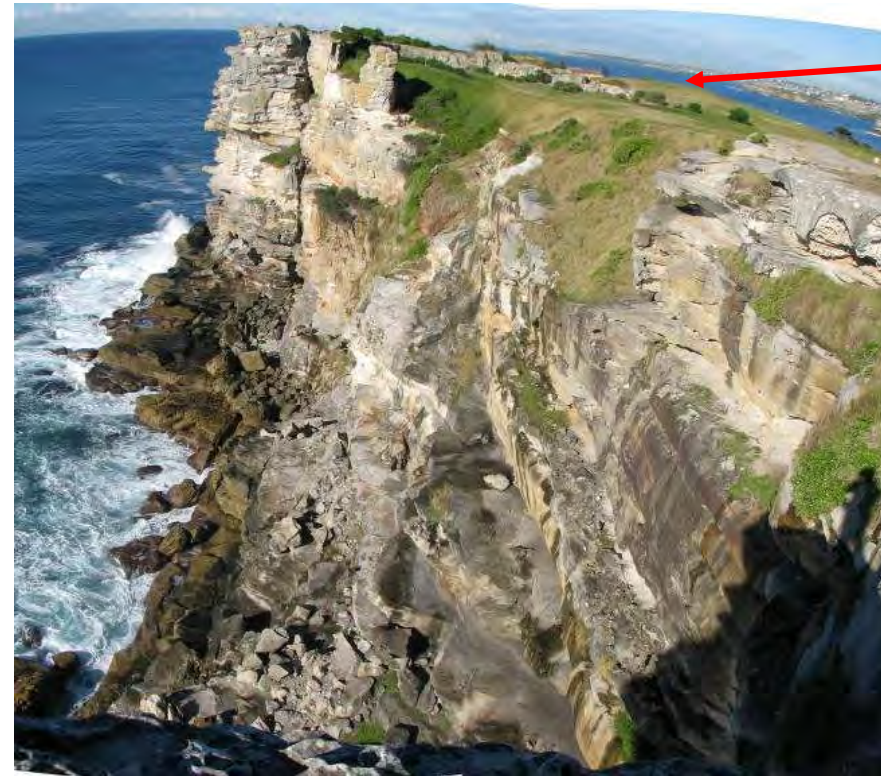
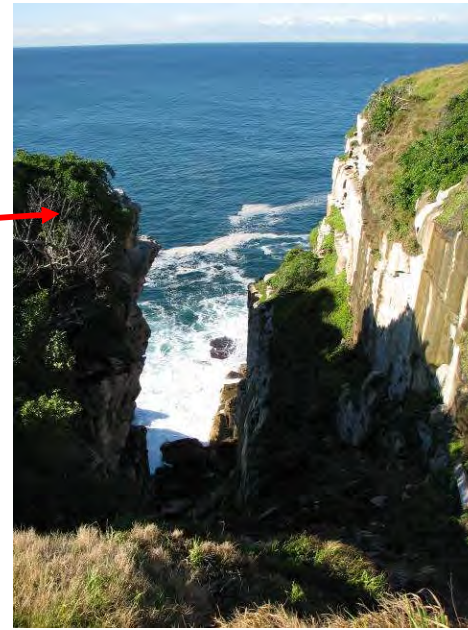
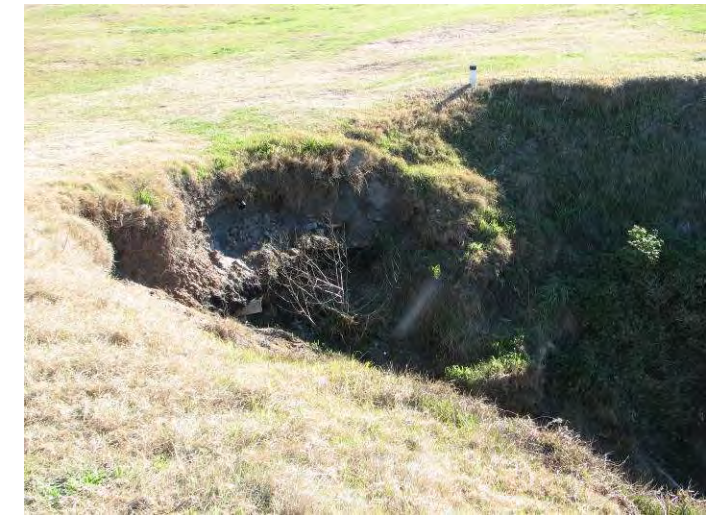
Cliff face below Bondi Golf Club

Instability of soil slope
